Report of Findings

Jetson Fire Origin & Cause Claim Number: 5015617702

Rimkus Matter No: 100162188

September 12, 2024 EXHIBIT A

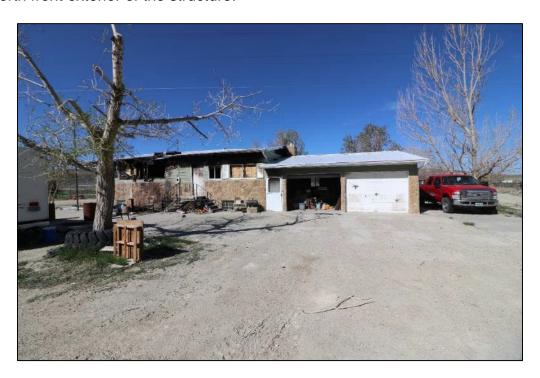
Photograph 1
The north front exterior of the structure.

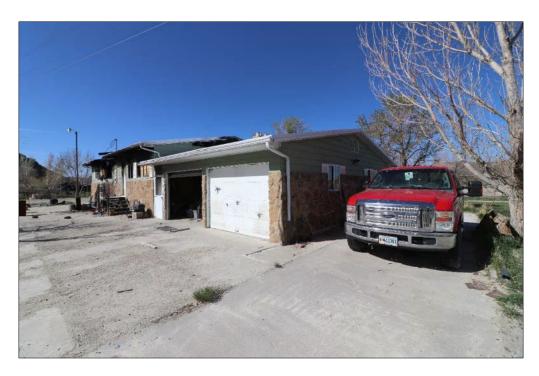
Photograph 2
The north and west exteriors of the structure.

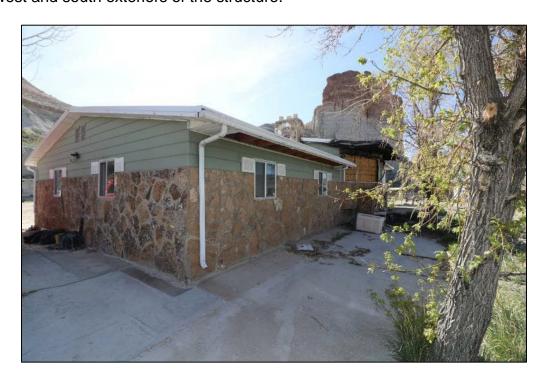
The west and south exteriors of the structure.

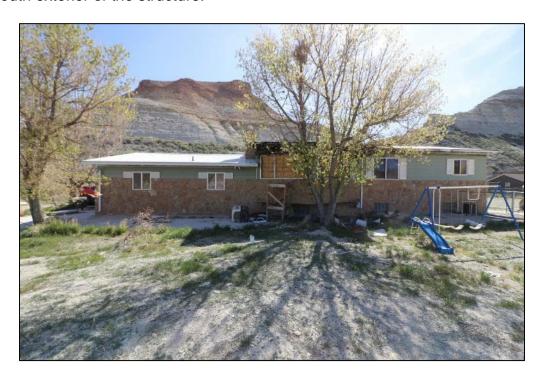
Photograph 4
The south exterior of the structure.

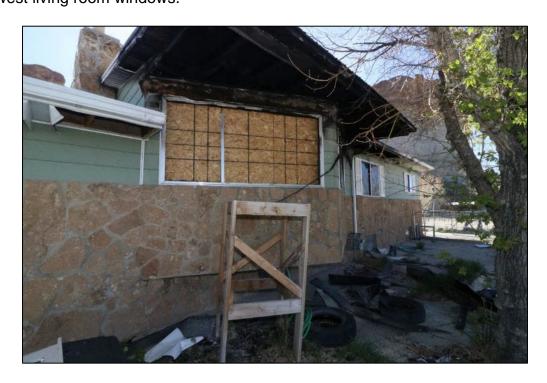
Photograph 5 The west living room windows.

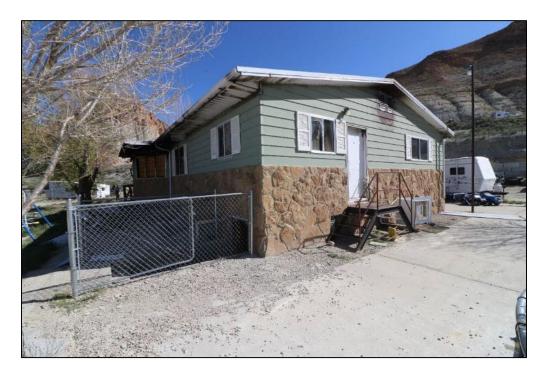
Photograph 6
The south and east exteriors of the structure.

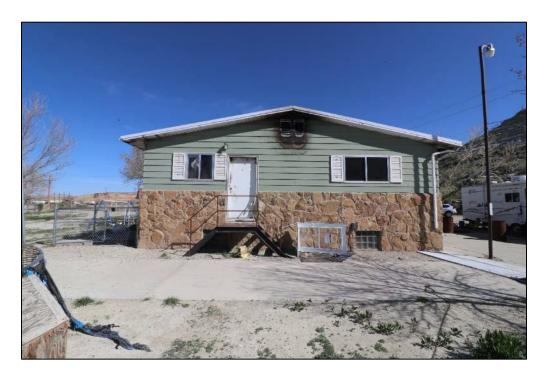
The east exterior of the structure.

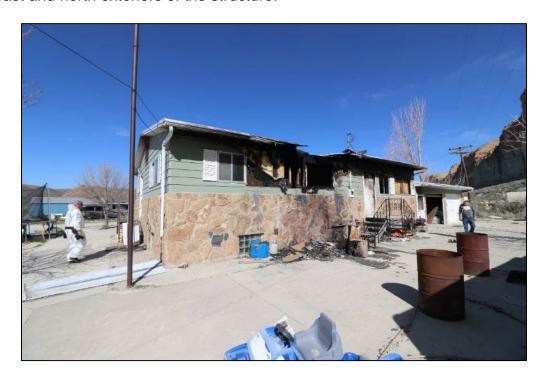
Photograph 8
The east and north exteriors of the structure.

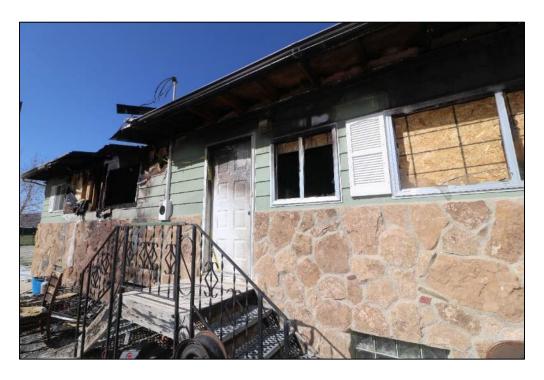
The north exterior of the structure.

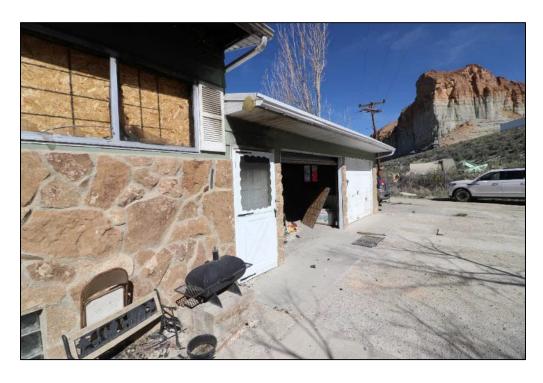
Photograph 12
The north exterior of the structure.

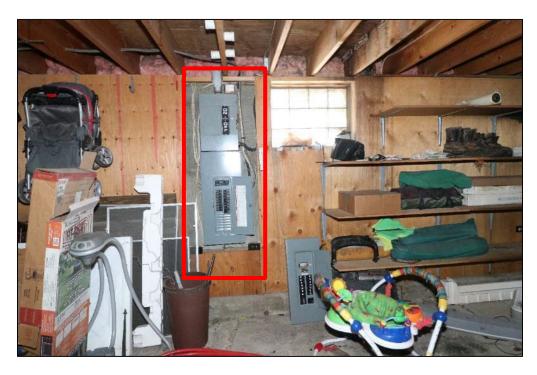
The main disconnect switch was located at the north interior wall of the basement. The main disconnect handle indicated it was in the ON position. No fire damage occurred to the main disconnect switch.

The first circuit-breaker panel was located at the north interior wall of the basement below the disconnect switch. All circuit breakers and the main circuit breaker were in the ON position. There were no tripped circuit breakers. No fire damage occurred to the circuit-breaker panel. Copper conductors in non-metallic sheathed cable provided branch circuit wiring.

The main disconnect switch and first circuit-breaker panel located on the north interior wall of the basement.

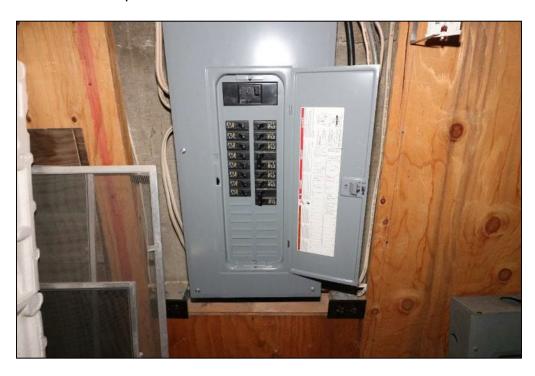
Photograph 16
The first circuit-breaker panel.

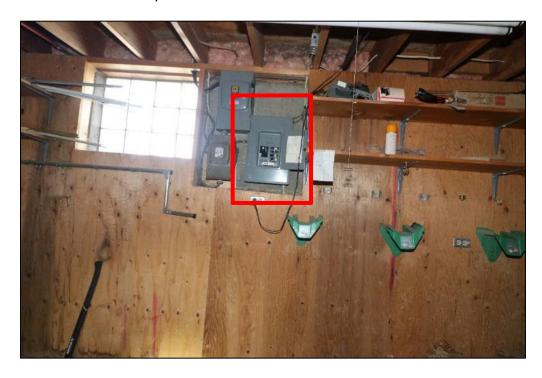
The second circuit-breaker panel.

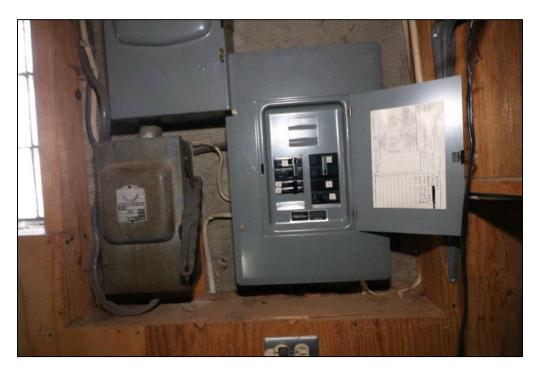
Photograph 18
The second circuit-breaker panel.

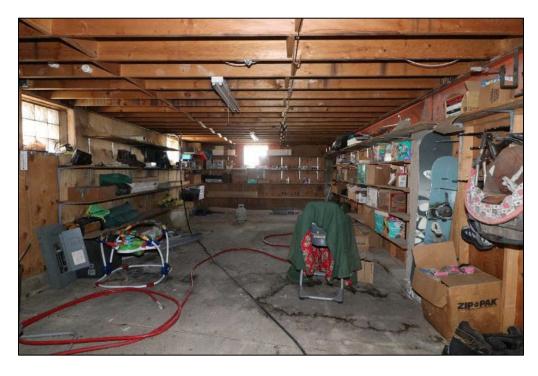
The north interior of the basement.

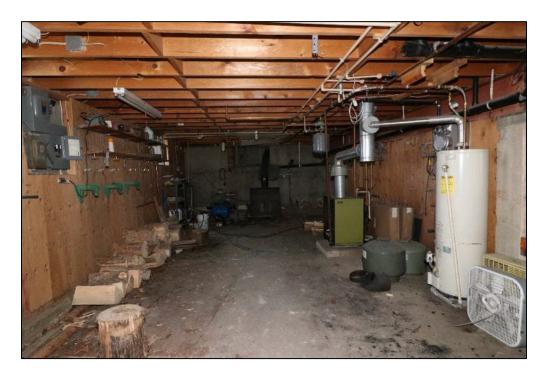
Photograph 20
The south interior of the basement.

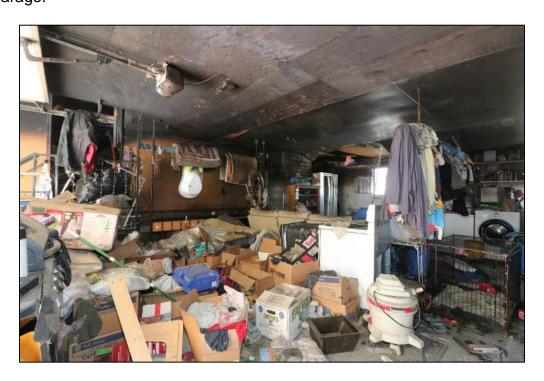
Photograph 21 The garage.

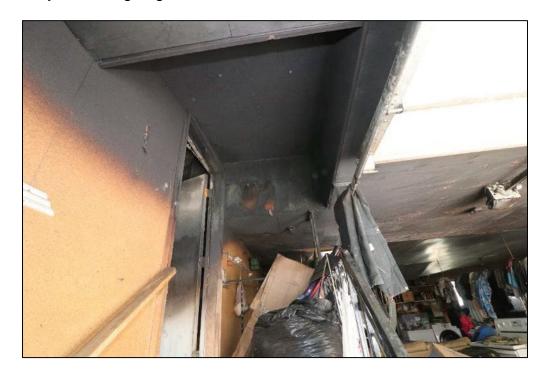
Photograph 22
The doorway from the garage to the kitchen.

Fire damage occurred in the garage and all damage increased with proximity to the kitchen/garage door. A ventilation pattern occurred on the east interior wall of the garage around the kitchen/garage door. This indicated fire progression from the kitchen to the garage through the kitchen/garage door. Fire patterns to the kitchen/garage door were consistent with this door being open during the fire.

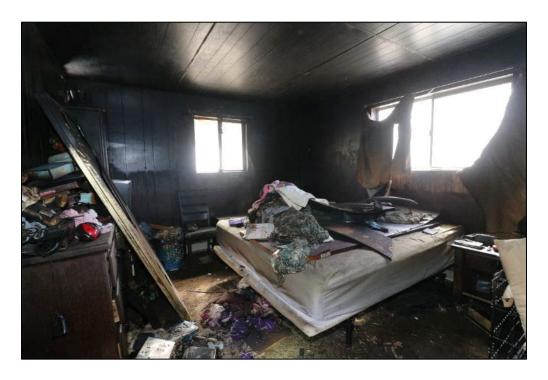
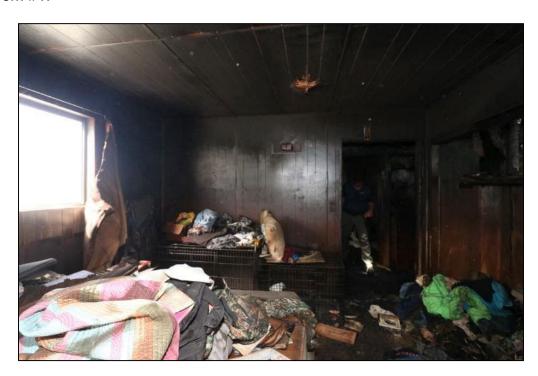
Photograph 23 Bedroom #1.

Photograph 24 Bedroom #1.

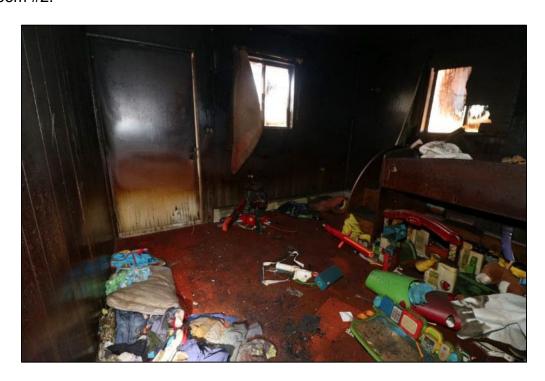
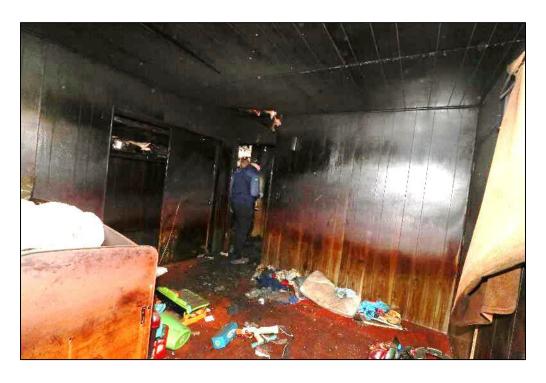
Photograph 25 Bedroom #2.

Photograph 26 Bedroom #2.

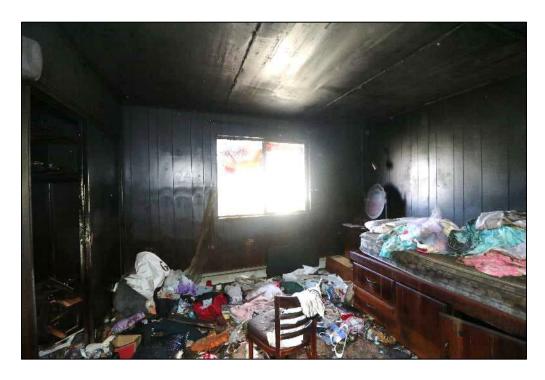
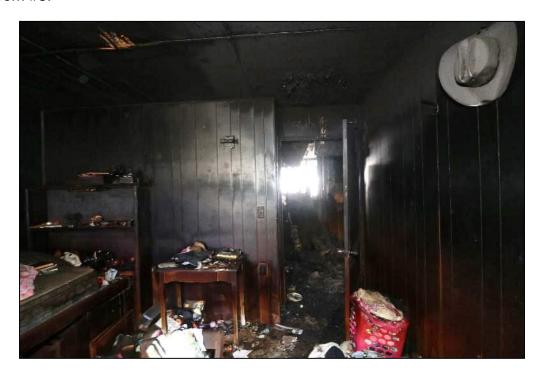
Photograph 27 Bedroom #3.

Photograph 28 Bedroom #3.

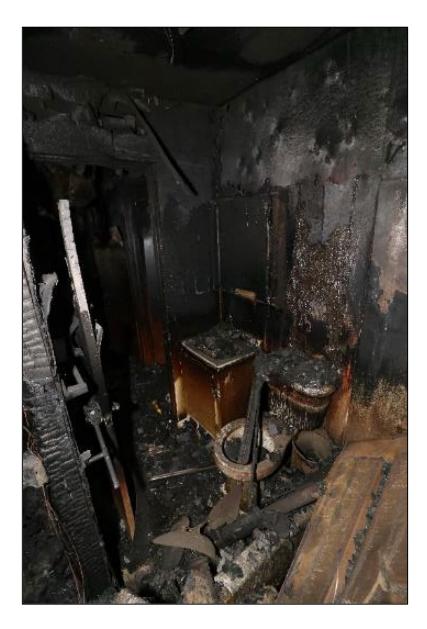
Photograph 29 Bathroom #1.

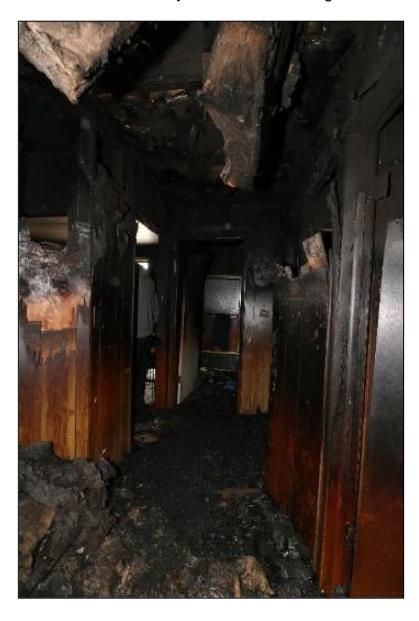
Photograph 31
The east portion of the bedroom hallway as seen while facing east.

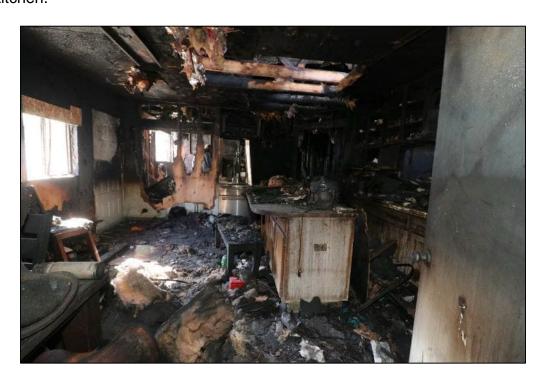
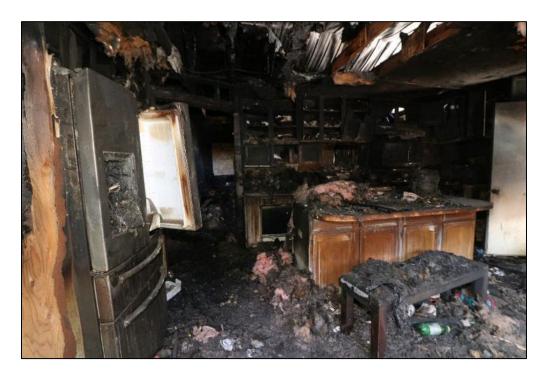
Photograph 33 The kitchen.

Photograph 34 The kitchen.

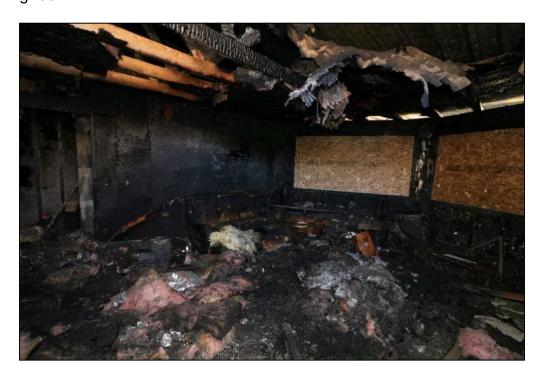
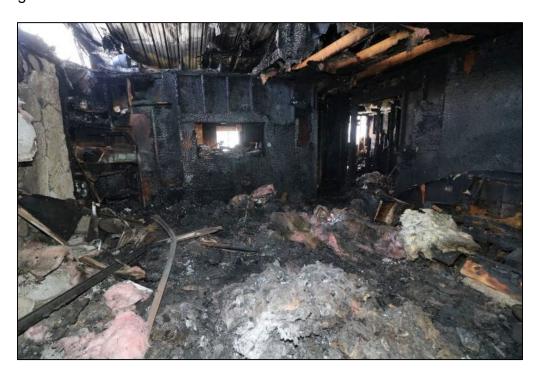
Photograph 35 The living room.

Photograph 36 The living room.

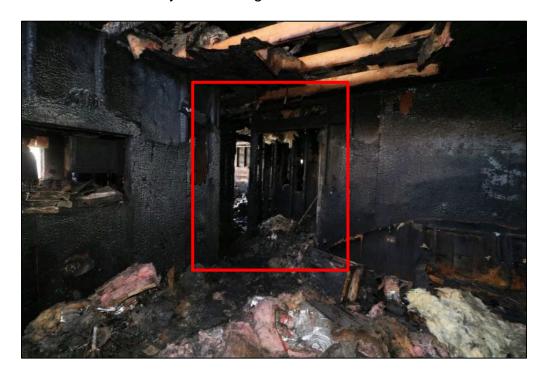
The entrance from the hallway to the living room.

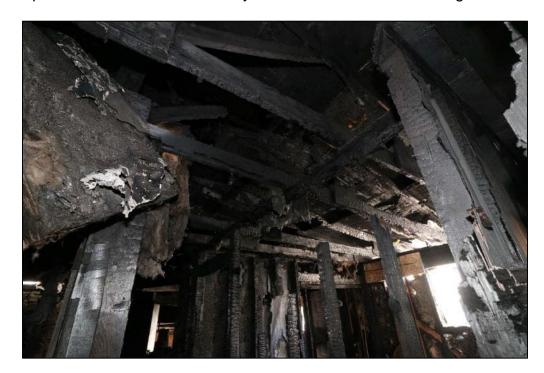
The west portion of the bedroom hallway and attic as seen while facing east.

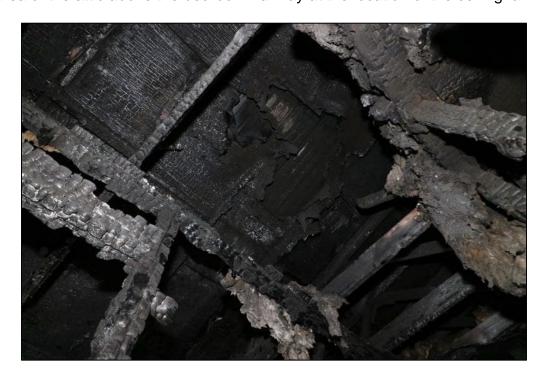
The area of the attic above the bedroom hallway at the location of the ceiling fan.

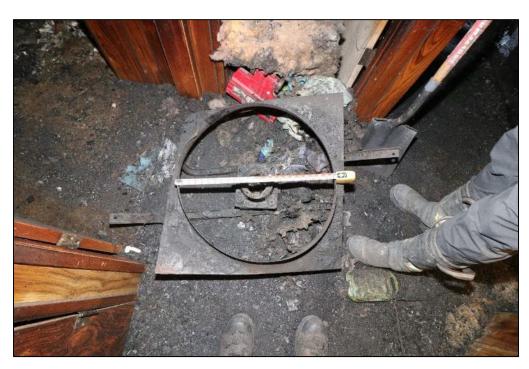
Photograph 42
The remains of the ceiling fan.

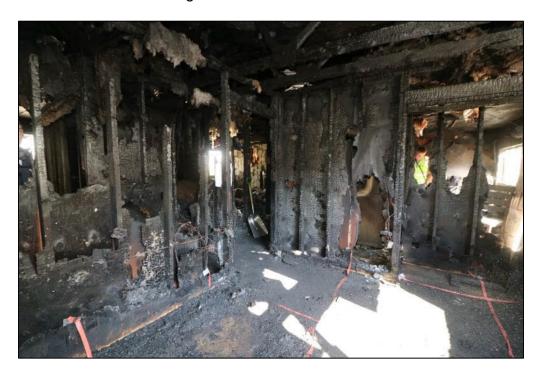
Photograph 43
Bedroom #4 as seen while facing southwest.

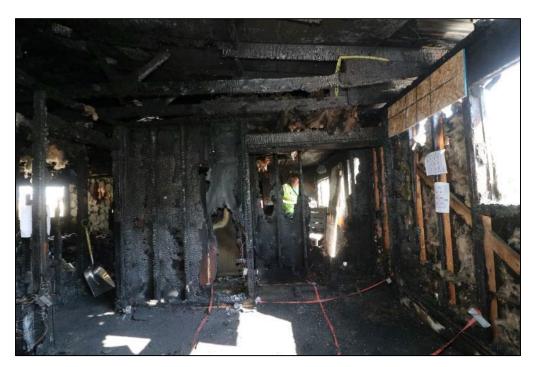
Photograph 44
Bedroom #4 as seen while facing west.

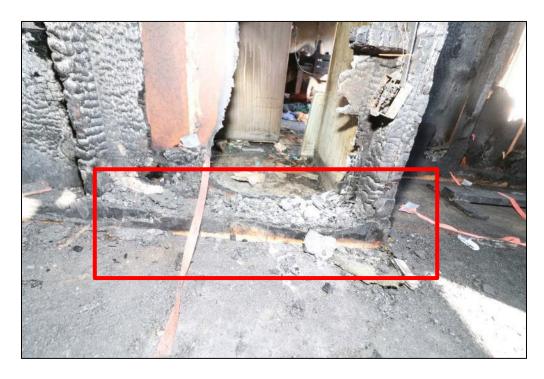
The remains of the hoverboard were discovered along the west interior wall of the bedroom. The location of the hoverboard measured approximately 36 inches from the bedroom door. The door was approximately 36 inches wide. The position of the hoverboard indicated the hoverboard was on the carpet floor in contact with the west interior wall. This is consistent with the unburned wood paneling at floor level. The hoverboard was positioned with one tire to the south and one tire to the north. Fire damage occurred to the hoverboard, and all fire damage increased with distance towards the north side. The south wheel was less consumed by the fire as compared to the north wheel. Fire movement patterns indicated fire progression from the north. The carpet below the hoverboard was intact and consistent with a protected area. The top portion of the hoverboard sustained more severe fire damage as compared to the bottom. Internal wiring and components sustained damage towards the top of the hoverboard with less fire damage towards the bottom. There was undamaged wire insulation within the hoverboard. The lack of internal damage throughout the hoverboard, the protected area of the carpet below the hoverboard, and fire patterns to the hoverboard are not consistent with a fire origin at the hoverboard. There is no indication that the fire originated at the hoverboard along the west interior wall of the bedroom.

The protected area below the inverted cone pattern indicates the location of the hoverboard.

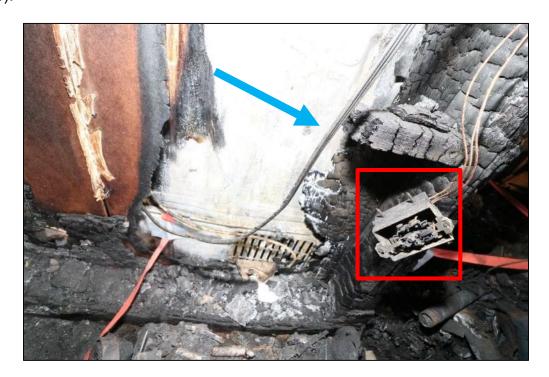
Photograph 47

The west Bedroom #4 receptacle (red box). The power cord for the refrigerator (blue arrow).

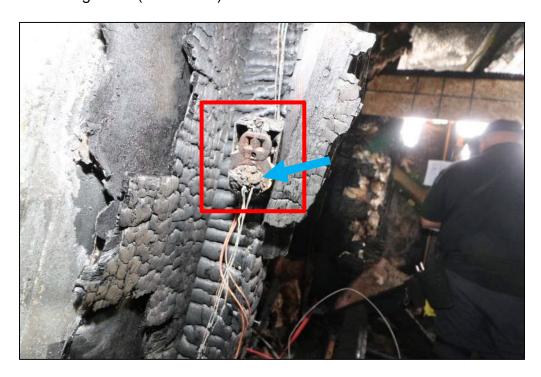
The refrigerator receptacle with two wires protruding from the receptacle. The wires were routed to the refrigerator (blue arrow).

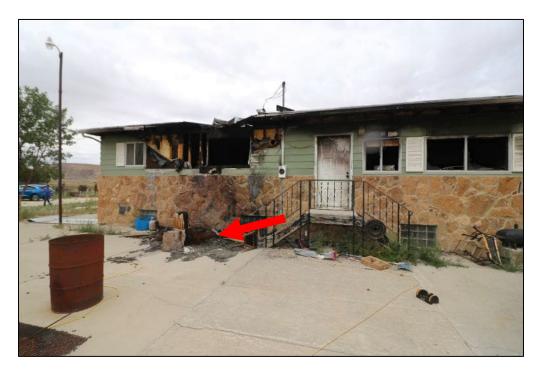
Fire damage occurred below the Bedroom #4 window. A yellow-colored resolidified plastic mass was located along the ground and abutted the north exterior stone veneer wall. It was determined that the resolidified mass was the remains of a plastic shed. Mass loss and consumption of the shed by fire occurred except for the underside, which was in contact with the concrete ground. The center of the mass was located more toward the left (east) side of the Bedroom #4 window. The remains of a metal-framed chair, portable electric heater, and miscellaneous contents were located on top of the resolidified mass.

The north exterior of the structure. The remains of the shed were discovered on the concrete ground (red arrow).

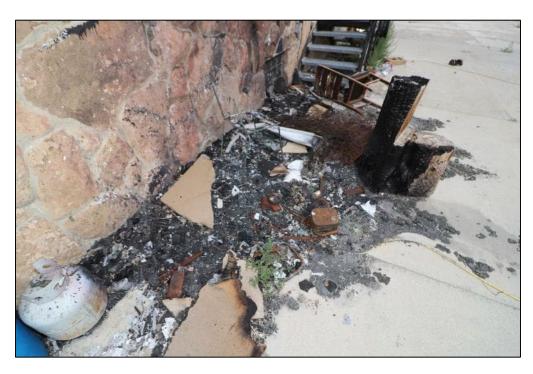
The remains of the portable electric heater.

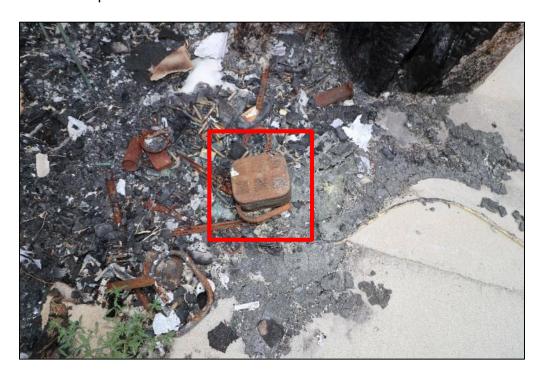
The remains of a portable electric heater were found within the shed. The portable electric heater was located at the northeast corner of the resolidified mass. The portable electric heater was identified as a model CZ250 1500-watt electric shop heater manufactured by Comfort Zone. The portable electric heater was equipped with overheat protection and had three settings, including fan, low and high. Fire damage occurred to the portable electric heater. An extension cord was observed around the remains of the portable electric heater. Evidence of arcing was observed at several locations on the extension cord/power cord for the portable electric heater.

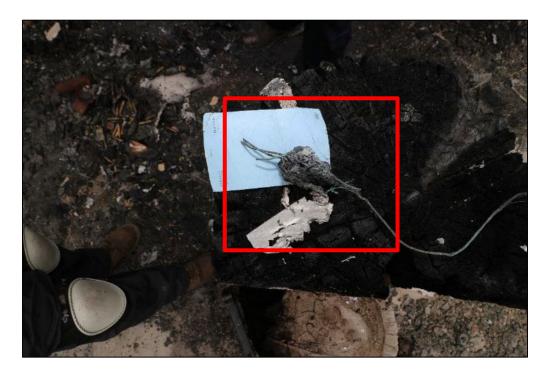
Photograph 55

Evidence of arcing occurred n the extension cord/power cord for the portable electric heater.

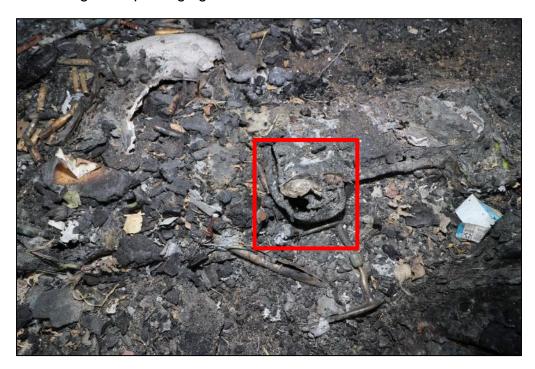
The remains of cigarette packaging foil were observed in the shed contents.

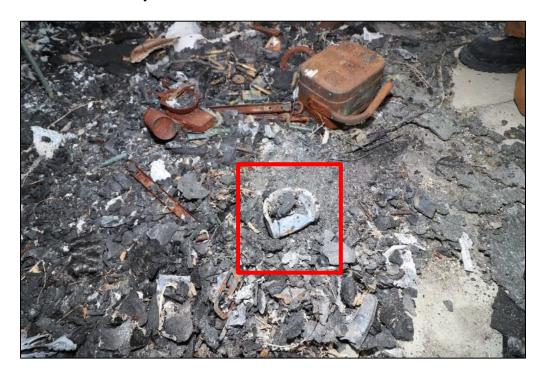
The remains of one ashtray were found in the fire debris. The ashtray measured approximately 3 1/4 inches in height and had a diameter of approximately 4 inches. The burned remains of cigarette butts were observed in the ashtray debris. The remains of the cigarette butt bucket, as described by the Wadsworth family, were not found in the fire debris. If the bucket was made of a combustible material the bucket may have been consumed by the fire.

The remains of the ashtray were observed in the contents of the shed.

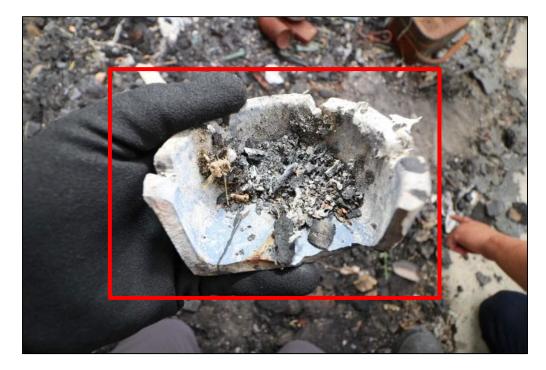
Photograph 59

The remains of the ashtray had remains of cigarette butts.

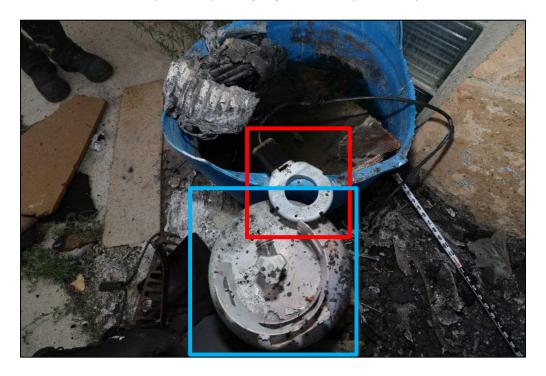
A large blue water bowl was located to the east of the shed. The top portion of the water bowl was melted and resolidified. The lower portions of the water bowl were intact. The damage to the water bowl is consistent with water in the bowl at the time of the fire. A deicer was found submerged in the water bowl. The de-icer was plugged into a yellow extension cord that was routed from a pole near the recreational vehicle parked to the north of the structure. The de-icer is a submersible electric heater that prevents water from freezing. The de-icer was identified as a Model C-50 and was manufactured by Farm Innovators. No fire damage occurred to the de-icer.

A propane tank was located next to the water bowl. The propane tank and valve were intact. Fire damage occurred to the west side of the tank that faced towards the shed. There are no fire patterns around the propane tank consistent with the burning of any escaping gas. There is no indication that propane escaped or was vented from the propane tank during or before the fire.

The remains of the de-icer (red box) and propane tank (blue box).
